CITY OF CLAREMONT

PARK IMPROVEMENT PLAN

**JANUARY 2025**

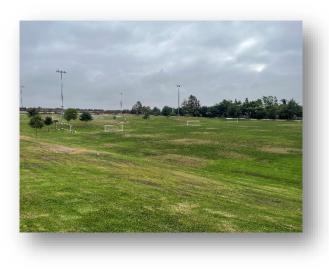
Padua Park is located within an area classified as "rural." This classification ensures that excessive light pollution does not occur, to preserve the natural essence of the area within the "rural" zone. Existing parking lot light fixtures produce adequate foot-candle levels in the majority of the parking lot as required by rural zone ordinances. However, the exit route from the parking lot to Padua Ave has foot-candle levels of zero. Multiple parking lot fixtures have missing or broken lenses, requiring repair as there is no protection remaining for the lamps. Current average light levels within parking lot are 0.01–0.8 foot-candles.

Pedestrian pathways have existing light fixtures along the pathway placed a great distance from each other, creating areas with zero foot-candles of illumination. Single-station exercise areas are located along the pedestrian pathway, some within these areas with zero foot-candles. Current average light levels along the pedestrian pathway are 0.01–0.8 foot-candles.

Padua Park					
Amenity	Description	Anticipated Fiscal Year Replacement	Anticipated Budget			
Playground		2028-2029	\$ 600,000			
Safety and Security Lighting	Priority: 3	Not Scheduled	\$ 225,000			
Sports Field Lights		2025-2026	<u>\$ 120,000</u>			
		TOTAL	\$ 945,000
